## 6.3 ARCHITECTURAL COMPONENTS

### 6.3.1 EXTERIOR WALL COMPONENTS

#### 6.3.1.1 ADHERED VENEER

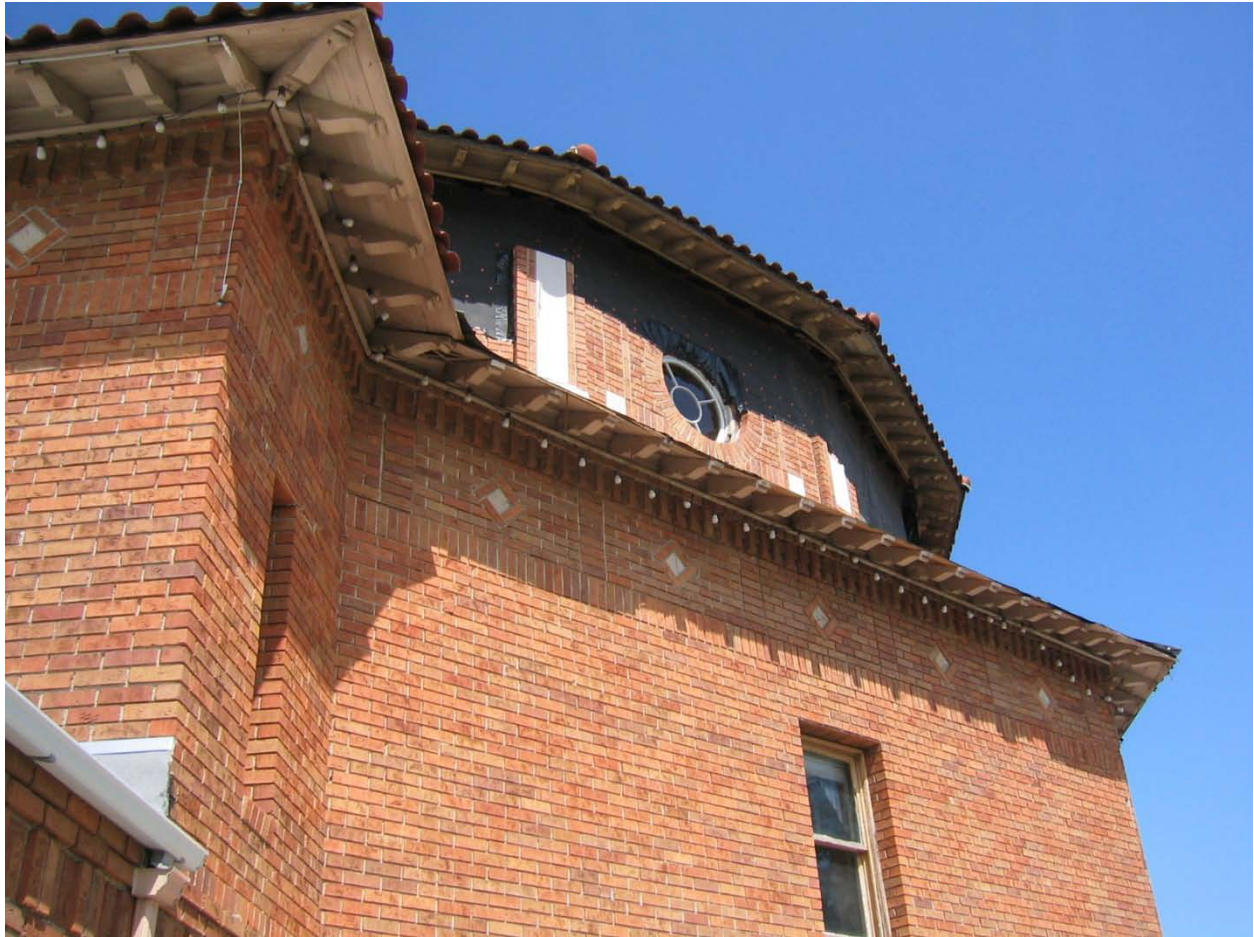
Figure 6.3.1.1-1 Failure of adhered masonry veneer at the Atascadero City Hall in the 2003 magnitude-6.5 San Simeon Earthquake (Photo courtesy of Mike Mahoney, FEMA).

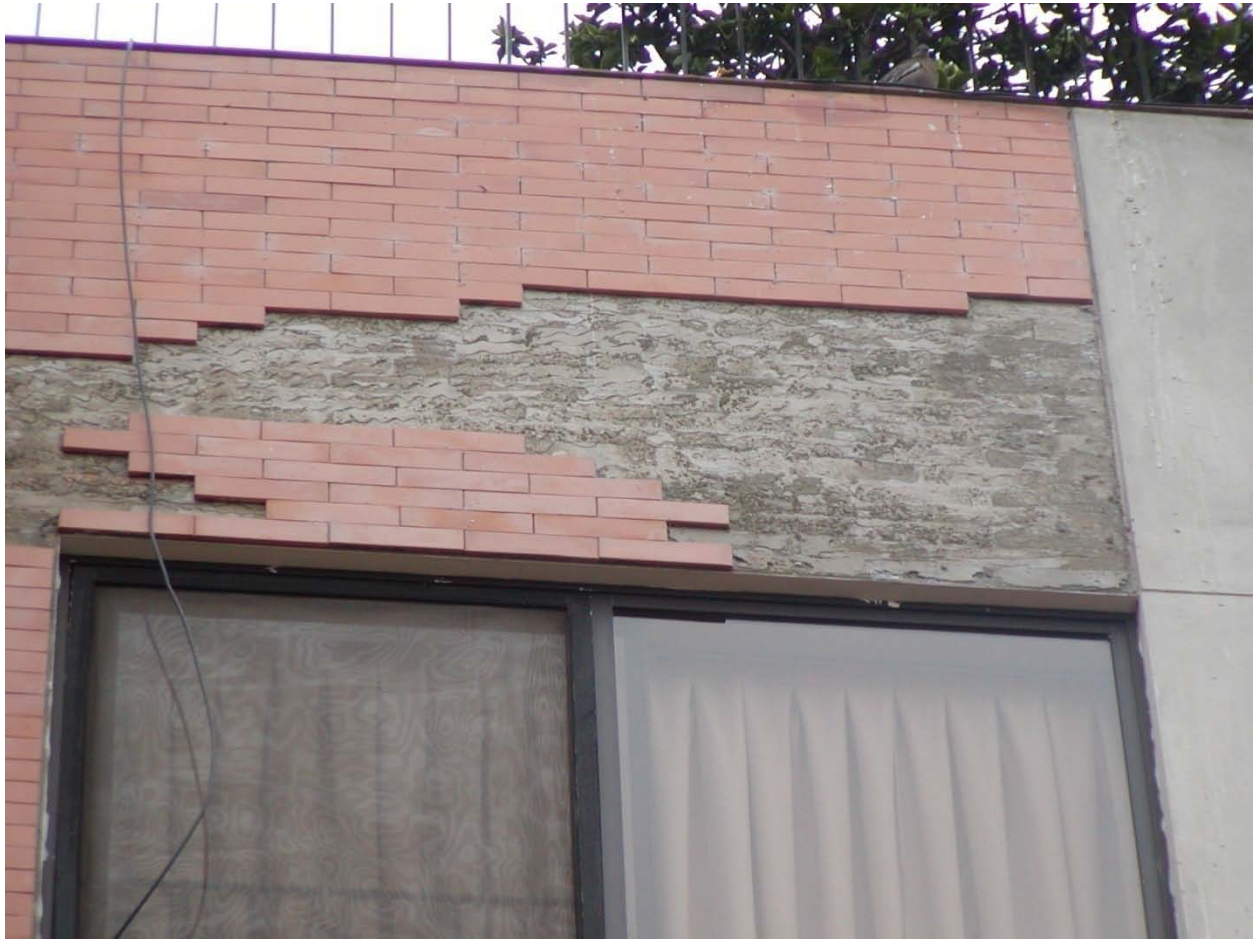
Figure 6.3.1.1-2 Close-up of failed adhered veneer. (Photo courtesy of Eduardo Fierro, BFP Engineers).

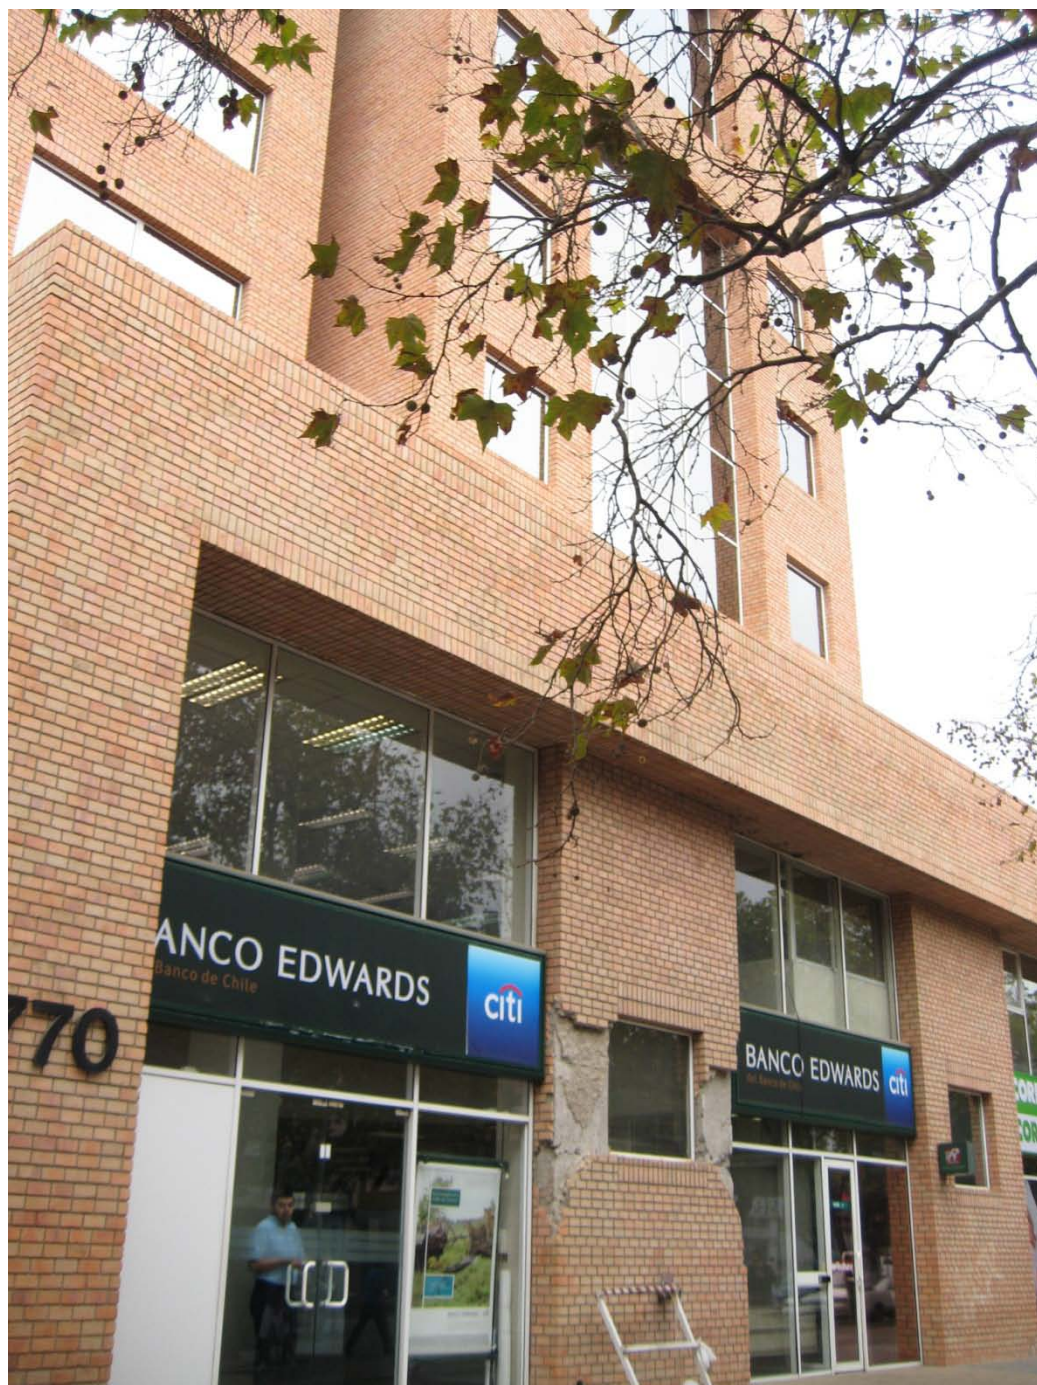
Figure 6.3.1.1-3

Cracked and spalled adhered veneer reveals incipient structural damage to concrete piers in Viña del Mar following the 2010 magnitude-8.8 Chile Earthquake. In this case, the areas of structural and nonstructural damage coincide; the adhered veneer remained intact over portions of the shear wall that did not deform significantly (Photo courtesy of Santiago Pujol, Purdue University).

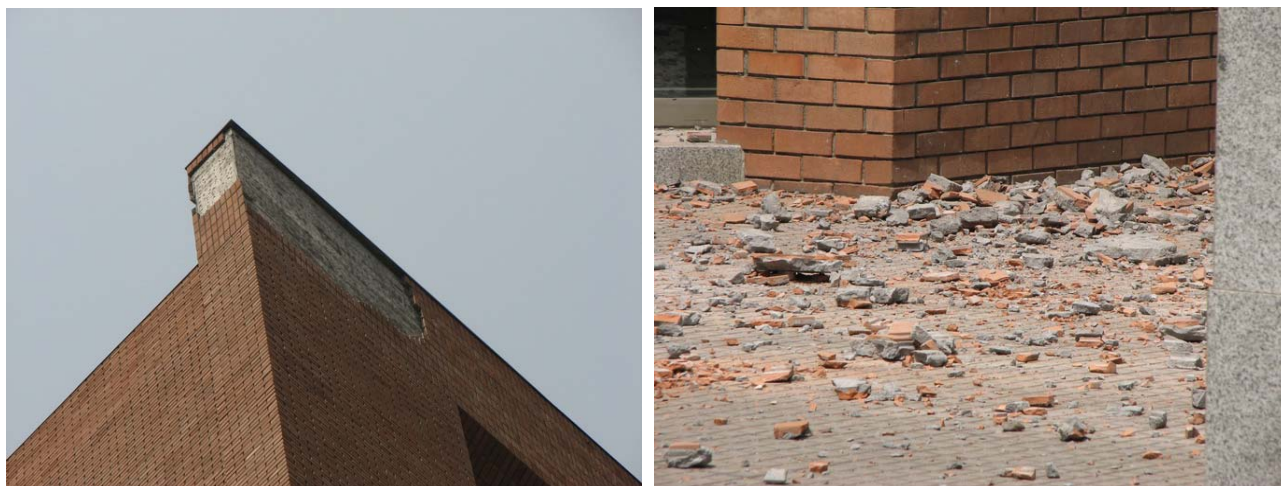
Figure 6.3.1.1-4 Failed adhered veneer fallen from parapet in Santiago following the 2010 magnitude-8.8 Chile Earthquake. (Photos courtesy of Antonio Iruretagoyena, Rubén Boroscheck & Associates)

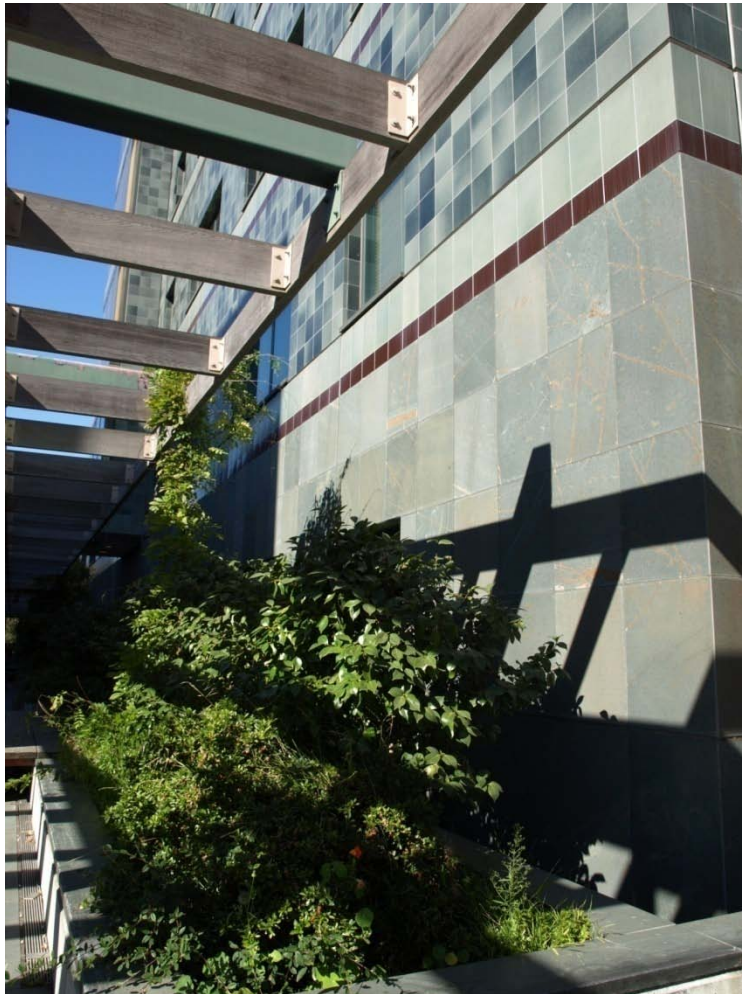
Figure 6.3.1.1-5 Landscaping strip restricts pedestrian access adjacent to adhered veneer façade. Larger units used within lower 6 feet; smaller units used above (Photo courtesy of Cynthia Perry, BFP Engineers).

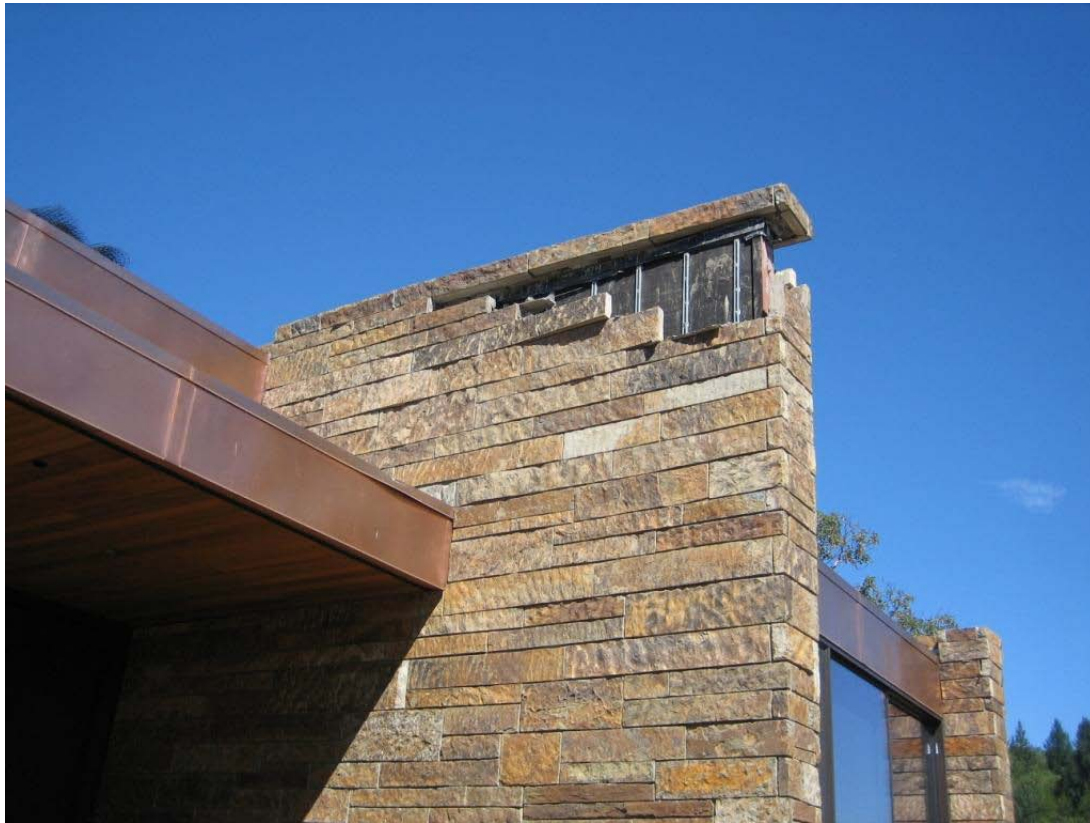
Figure 6.3.1.2-1      Fallen sandstone veneer as a result of a magnitude-4.4 earthquake in northern California. Post-earthquake investigation revealed missing dovetail anchors, missing pencil rods, and weak stone-to-mortar bond (Photo courtesy of Simpson Gumpertz and Heger).

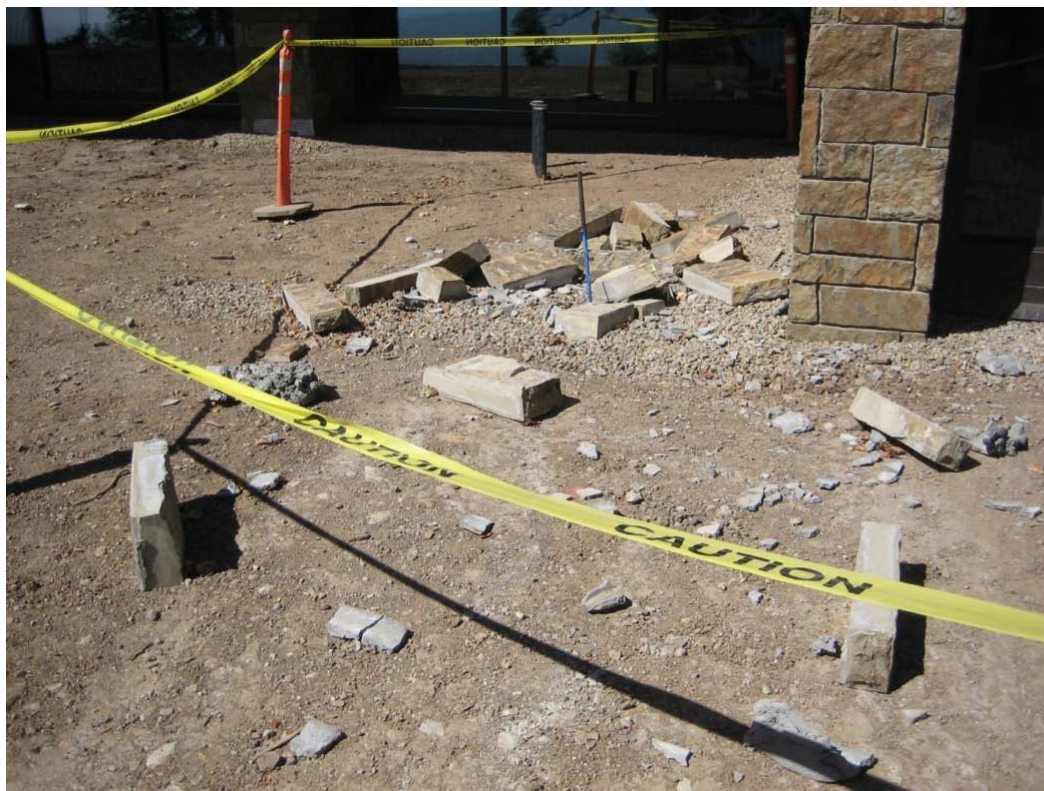
Figure 6.3.1.2-2      Fallen sandstone veneer as a result of a magnitude-4.4 earthquake (Photo courtesy of Simpson Gumpertz and Heger).

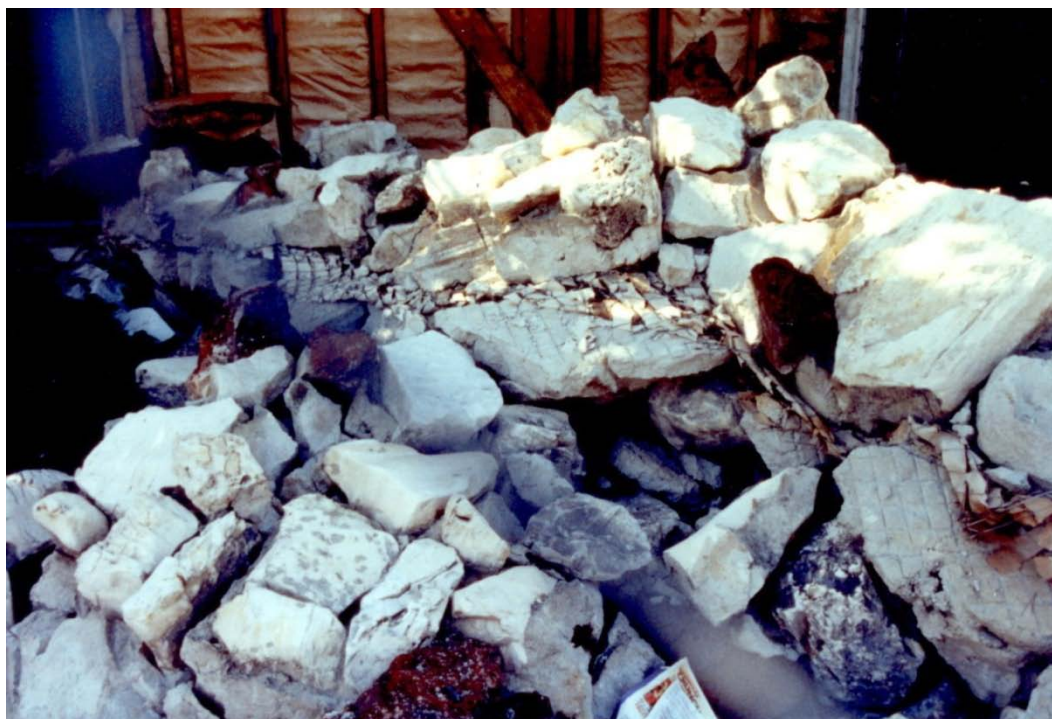
Figure 6.3.1.2-3      Rubble from failed anchored veneer as a result of the 1994 Northridge Earthquake (Photo courtesy of Robert Reitherman).

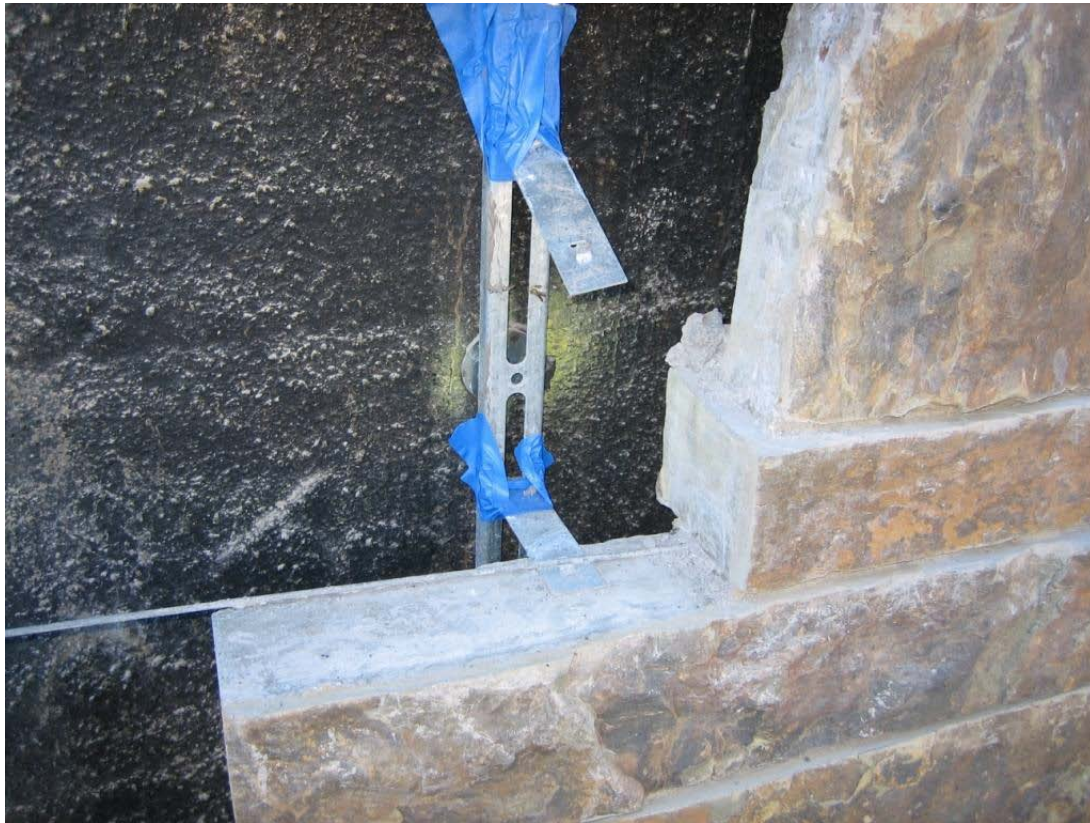
Figure 6.3.1.2-4 Installation of stone veneer showing anchorage to steel dovetail clips which are fastened to steel studs bolted to the grouted reinforced masonry wall behind (Photo courtesy of Simpson Gumpertz and Heger).

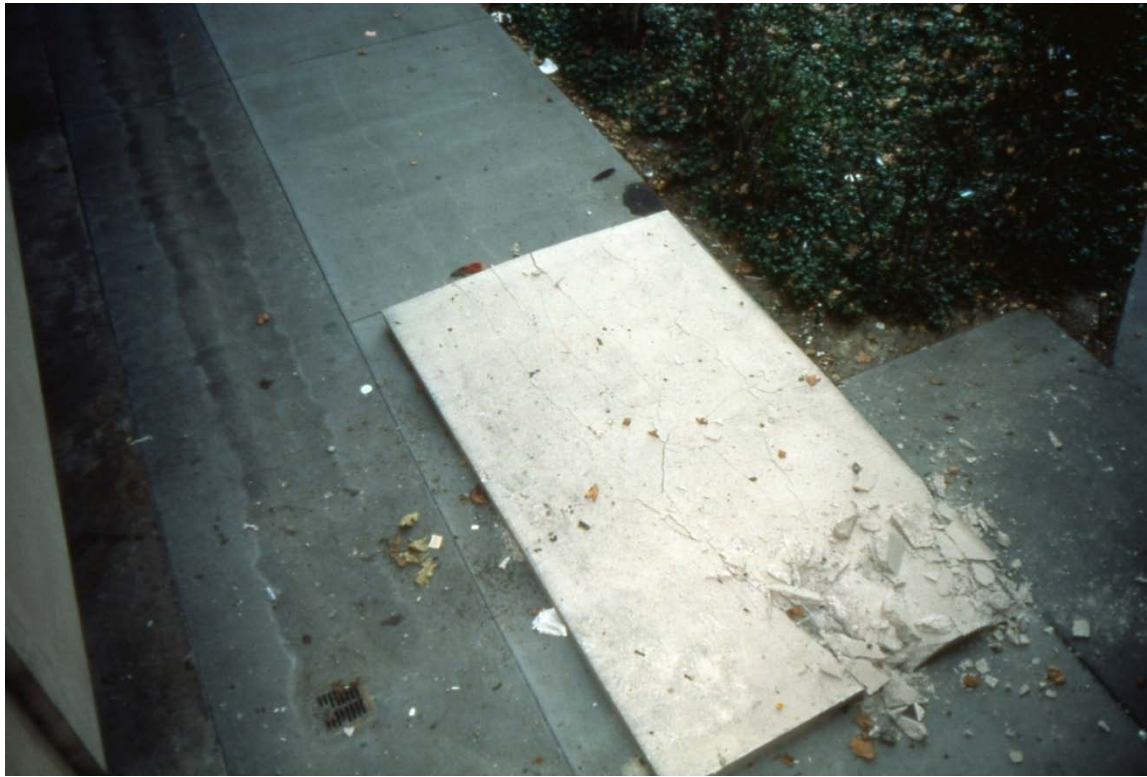
Figure 6.3.1.3-1 Failure of precast panel at parking garage that resulted in fatality in the 1987 magnitude-5.9 Whittier, California earthquake (Photo courtesy of Degenkolb Engineers).

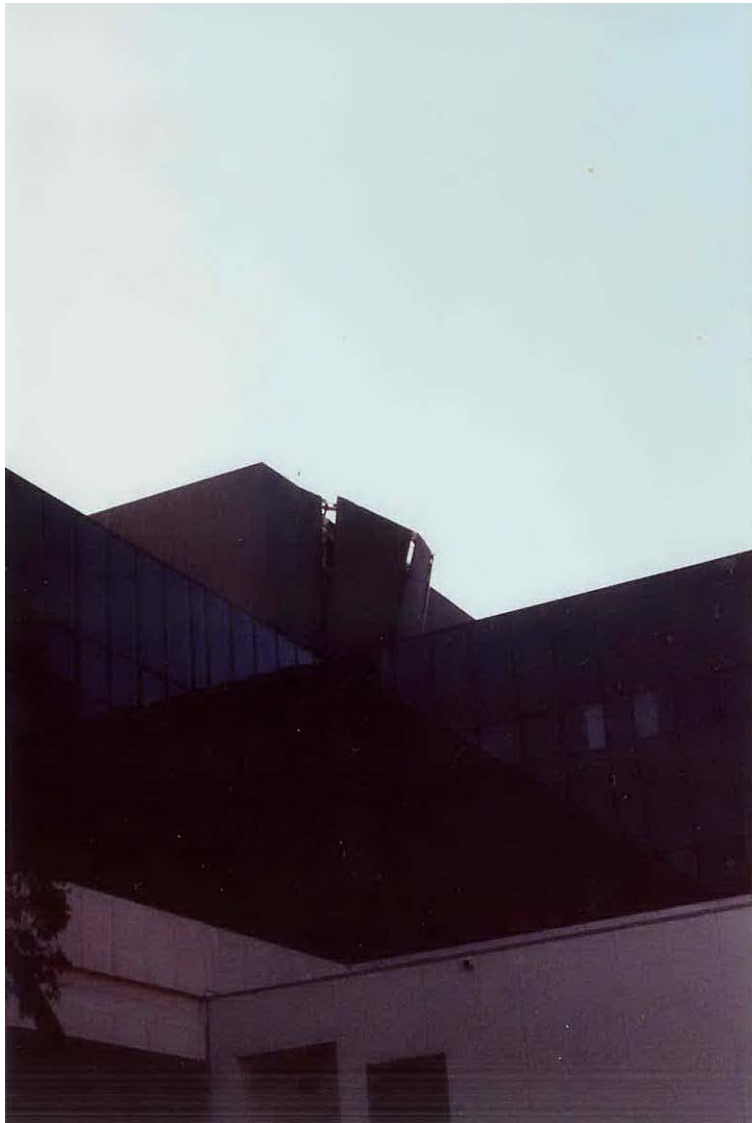
Figure 6.3.1.3-2      Precast panel failure at the top floor of a hospital in the 1994 magnitude-6.7 Northridge Earthquake (Photo courtesy of OSHPD).

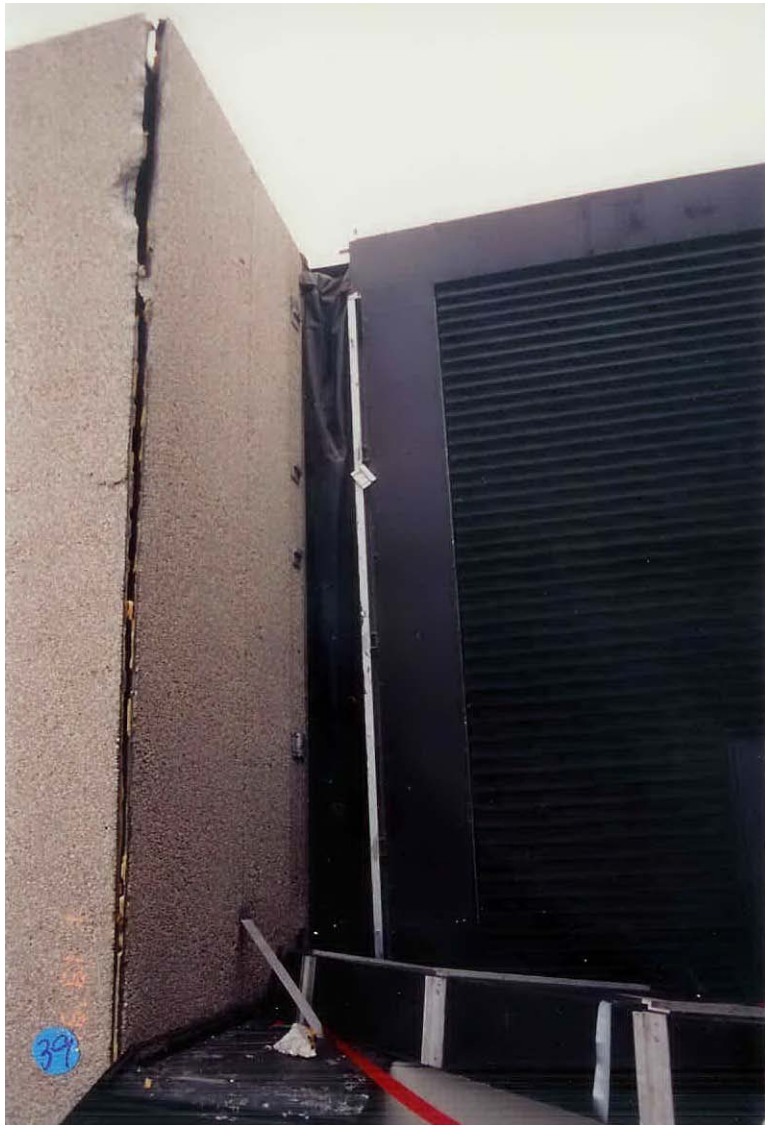
Figure 6.3.1.3-3      Precast panel damage at a building corner in the 1994 Northridge Earthquake (Photo courtesy of OSHPD).

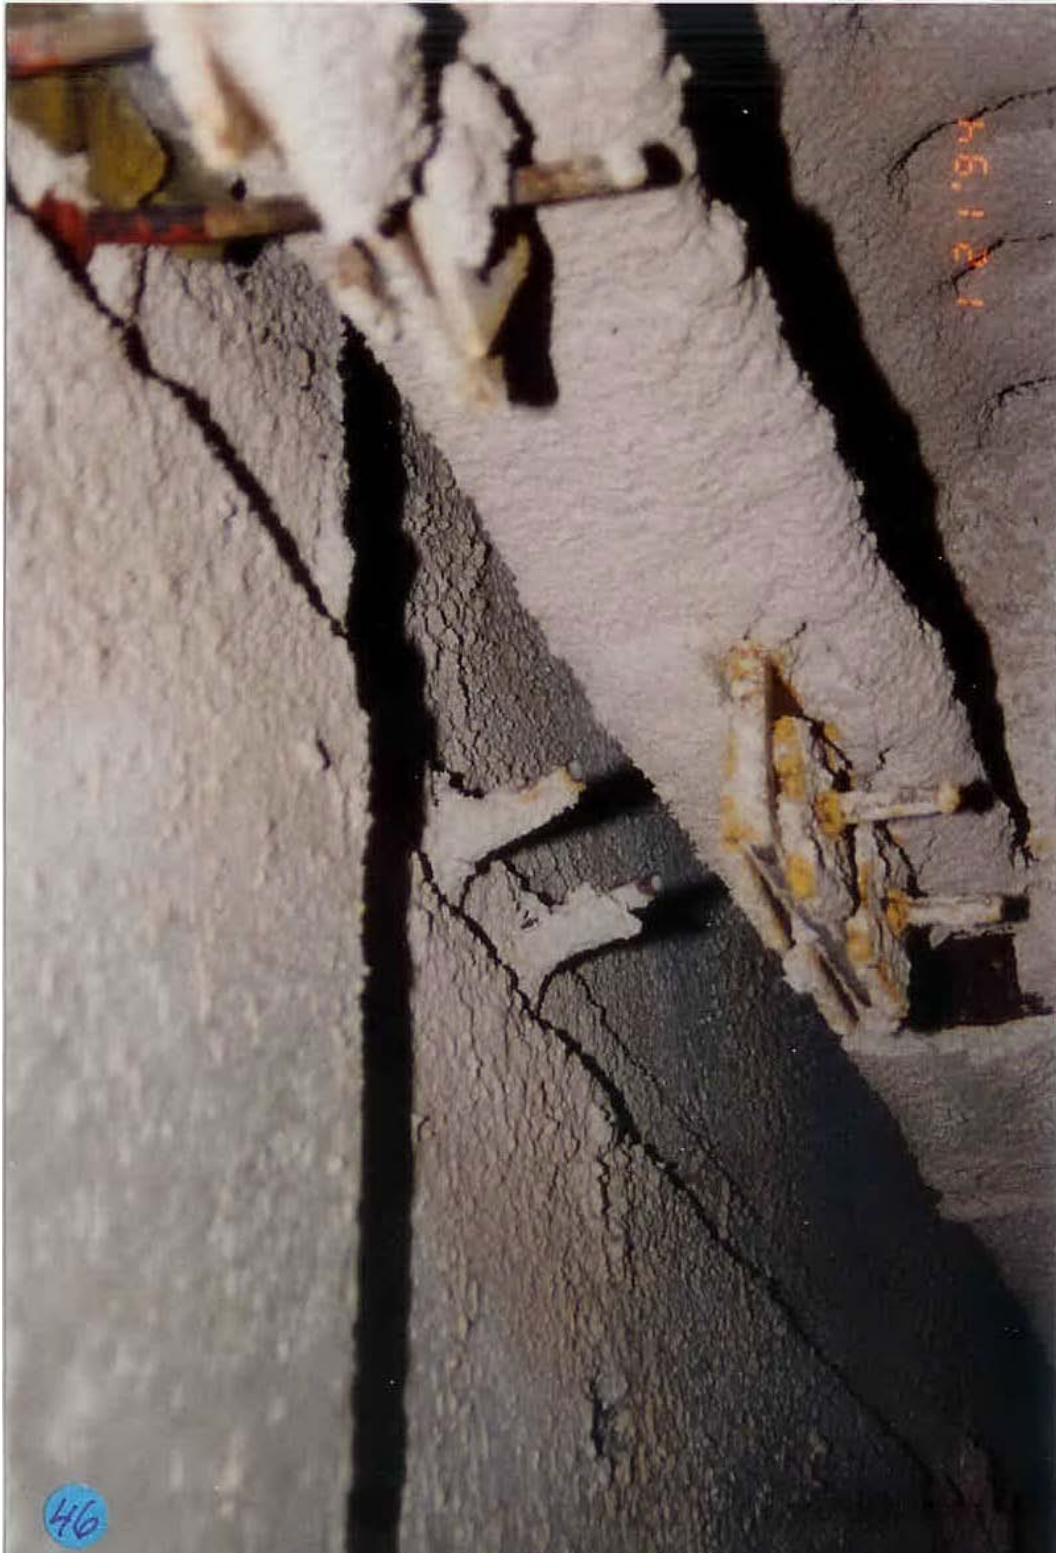
Figure 6.3.1.3-5 Close-up photo of two fractured connection bolts in a prefabricated panel in the 1994 Northridge Earthquake; corrosion of the rods may have contributed to the failure. (Photo courtesy of OSHPD).

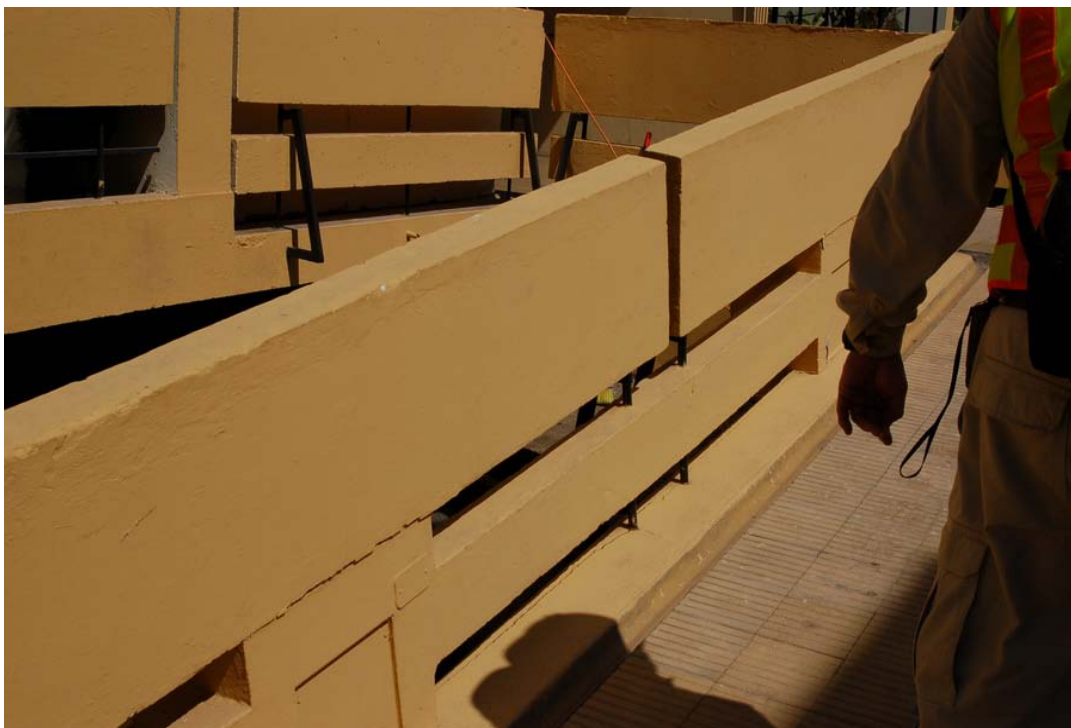
Figure 6.3.1.3-6 Residential building with precast concrete corridor and balcony railing panels. Some panels were damaged and subsequently many were removed to prevent falling. Location in Rancagua, Chile 154 miles northeast of the epicenter; estimated PGA of 0.3g during the 2010 magnitude-8.8 Chile Earthquake (Photo courtesy of Antonio Iruretagoyena, Rubén Boroscchek & Associates).

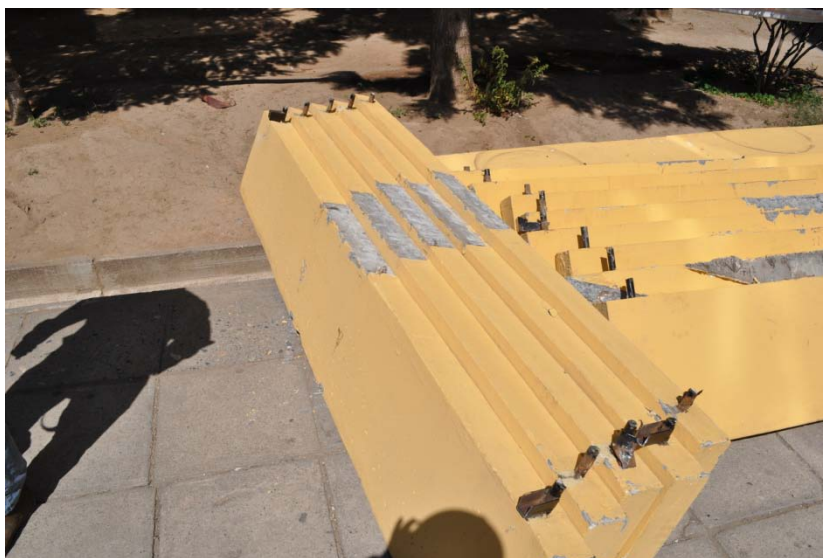
Figure 6.3.1.3-7 Numerous precast panels removed to prevent falling; detail from residential building in Rancagua, Chile above. These panels had a bearing seat at the center and supported on steel dowels at either end (Photo courtesy of Eduardo Fierro, BFP Engineers).

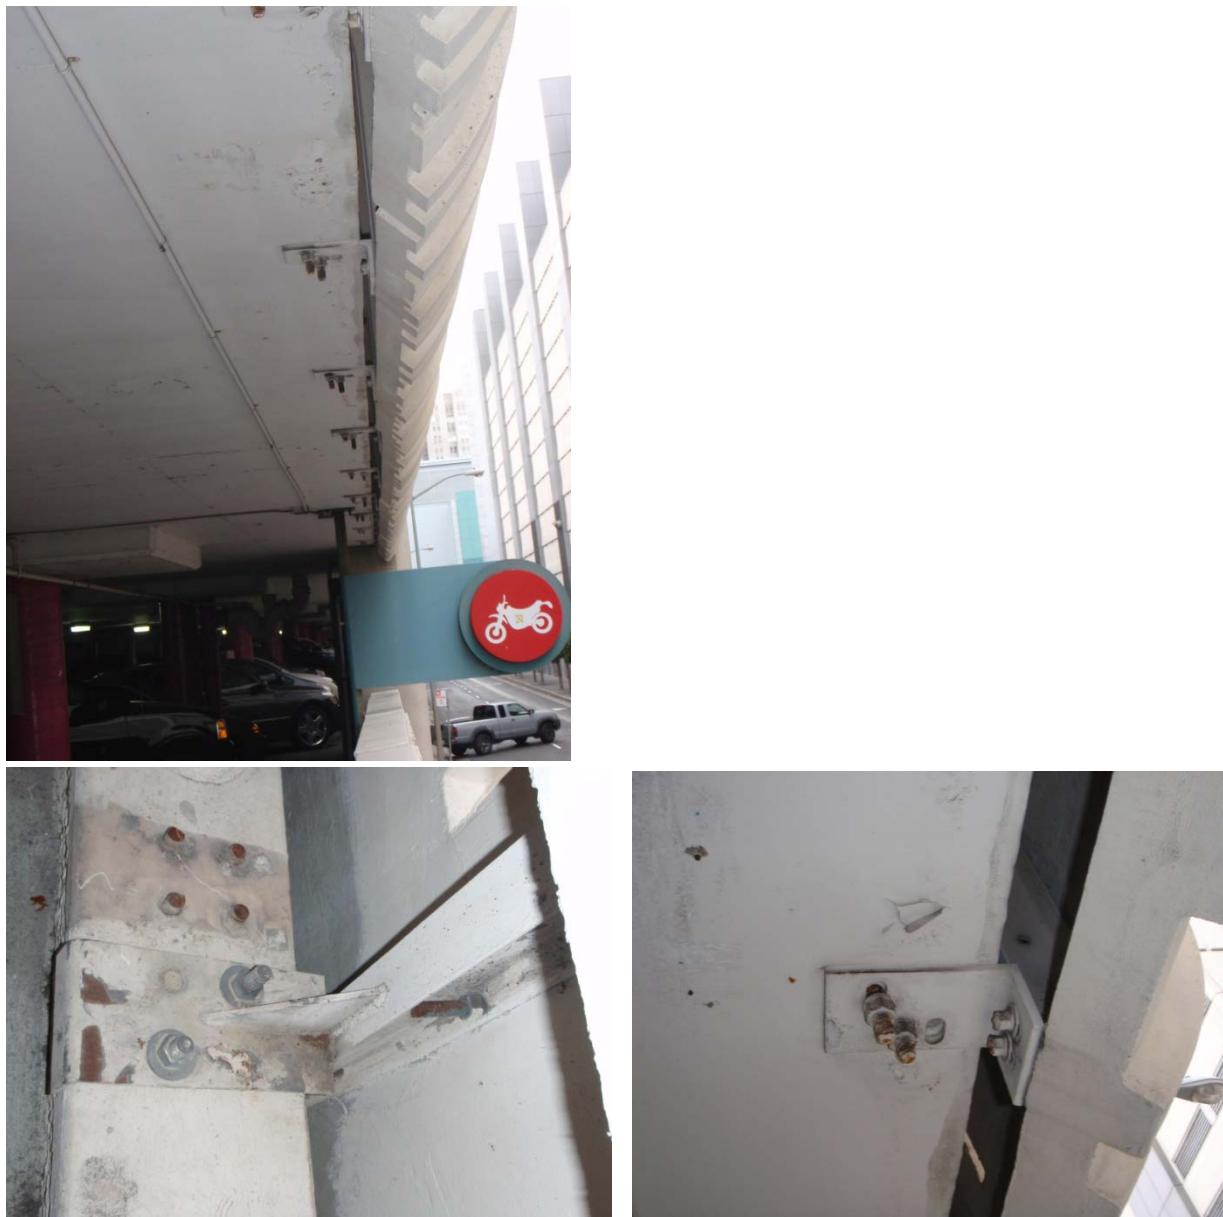
Figure 6.3.1.3-8 Precast spandrel panel in San Francisco parking garage supported by bearing connections near top of panel (left) and slotted connections at bottom of panel (right); panels have four connections each. The remnants of a previous nonductile connection detail are visible in the photo at left (Photo courtesy of Cynthia Perry, BFP Engineers).

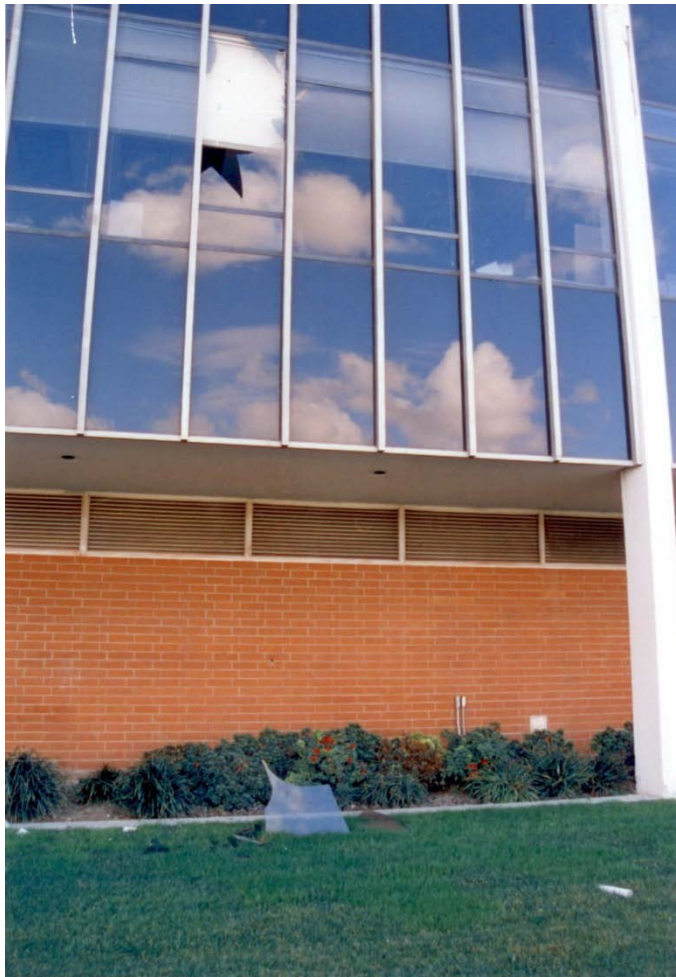
Figure 6.3.1.4-1      Shard of broken untempered glass that fell several stories from a multistory building in the 1994 Northridge Earthquake (Photo courtesy of Wiss, Jenney, Elstner Associates).

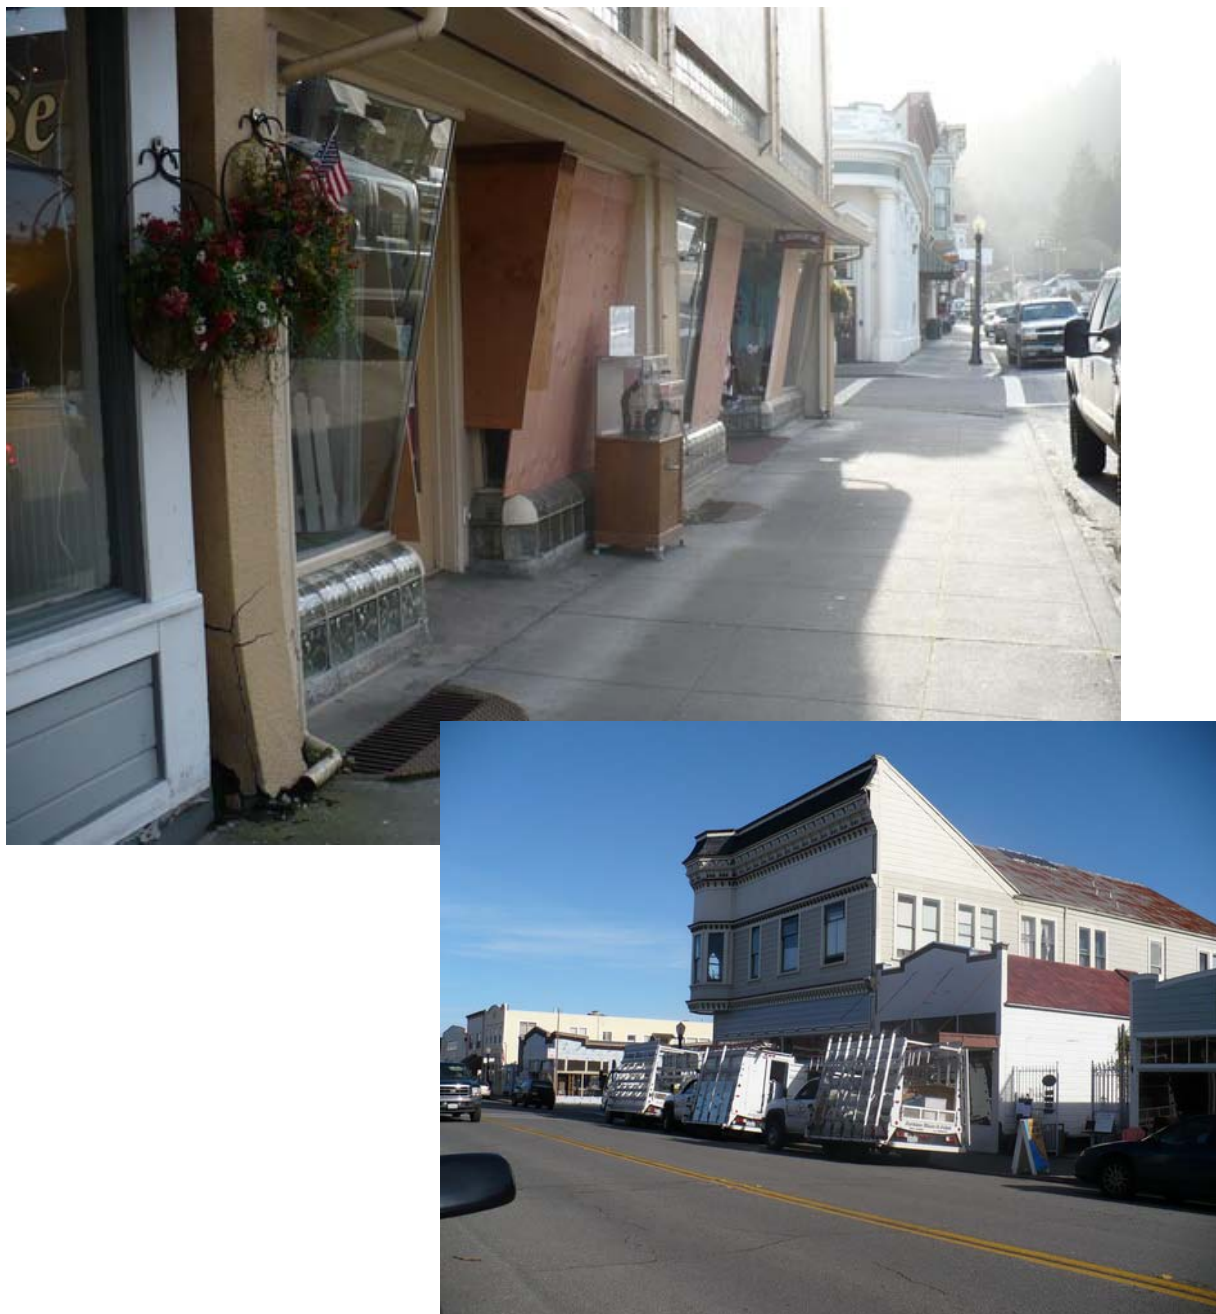
Figure 6.3.1.4-2 Scenes in Ferndale, California following the 2010 magnitude-6.5 Eureka Earthquake. 50% of the glazing on Main Street was cracked (Photos courtesy of Bret Lizundia, Rutherford & Chekene).

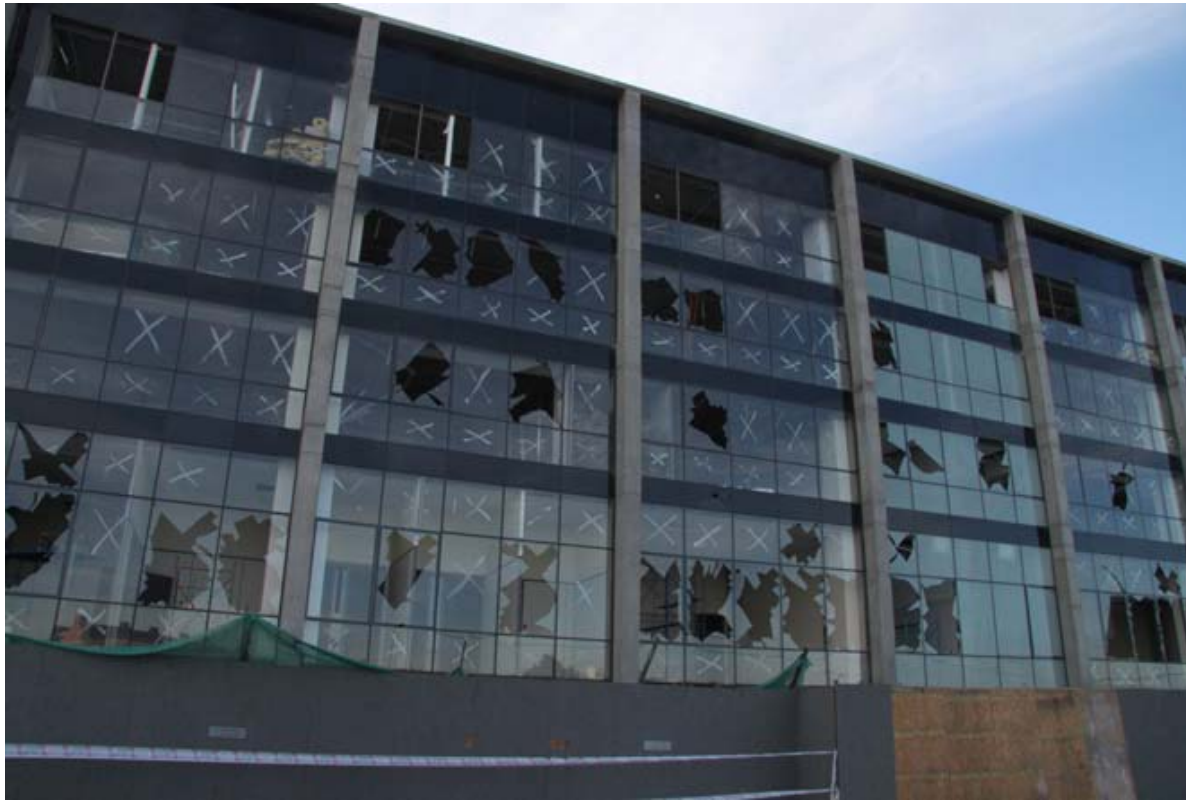
Figure 6.3.1.4-3      Glazing damage was observed in many residential and commercial buildings and hospitals throughout central Chile following the 2010 magnitude-8.8 Chile Earthquake (Photo courtesy of Eduardo Miranda, Stanford University).

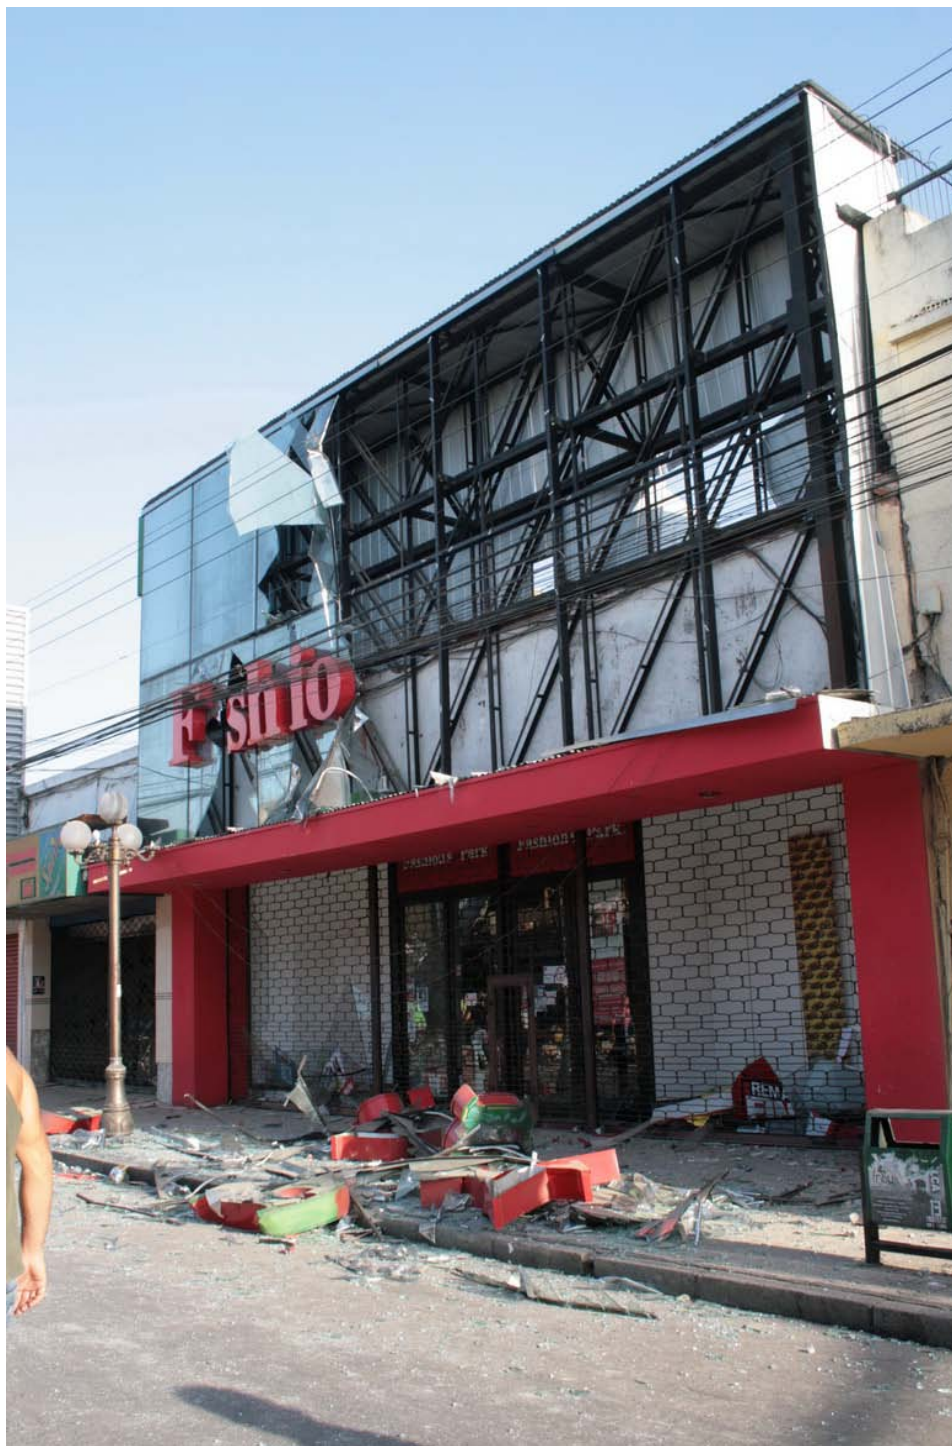
Figure 6.3.1.4-4      Glazing damage, due in part to pounding with the structure at right during the 2010 Chile Earthquake (Photo courtesy of Antonio Iruretagoyena, Rubén Boroscheck & Associates).

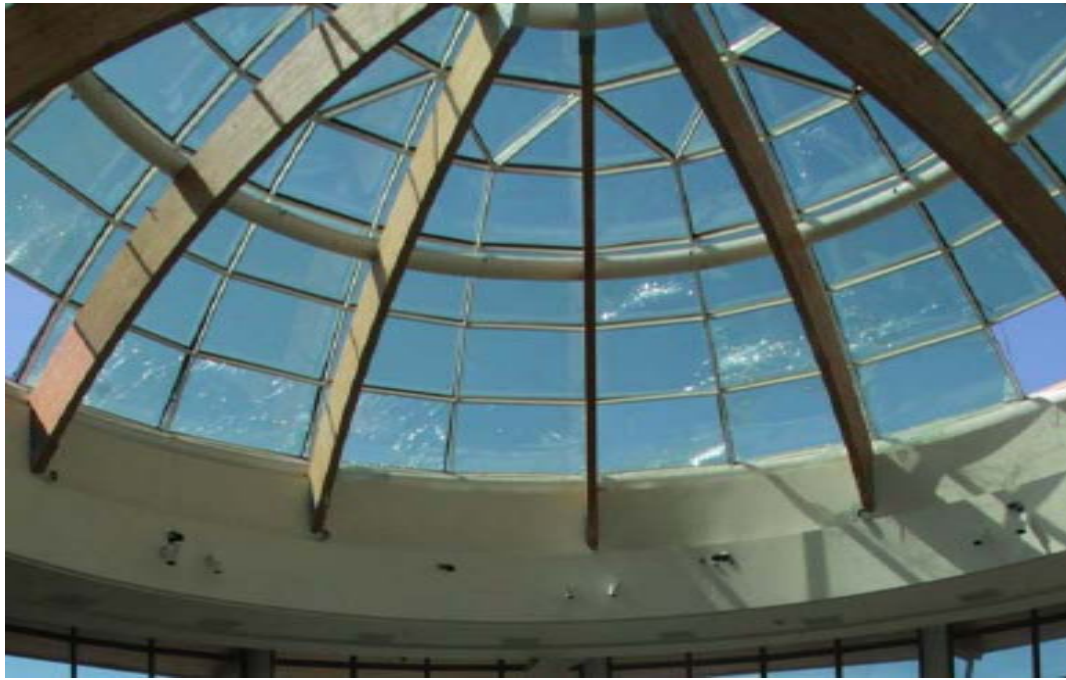
Figure 6.3.1.4-5 Overhead glazing damage from the 2010 Chile Earthquake (Photo courtesy of Eduardo Miranda, Stanford University).

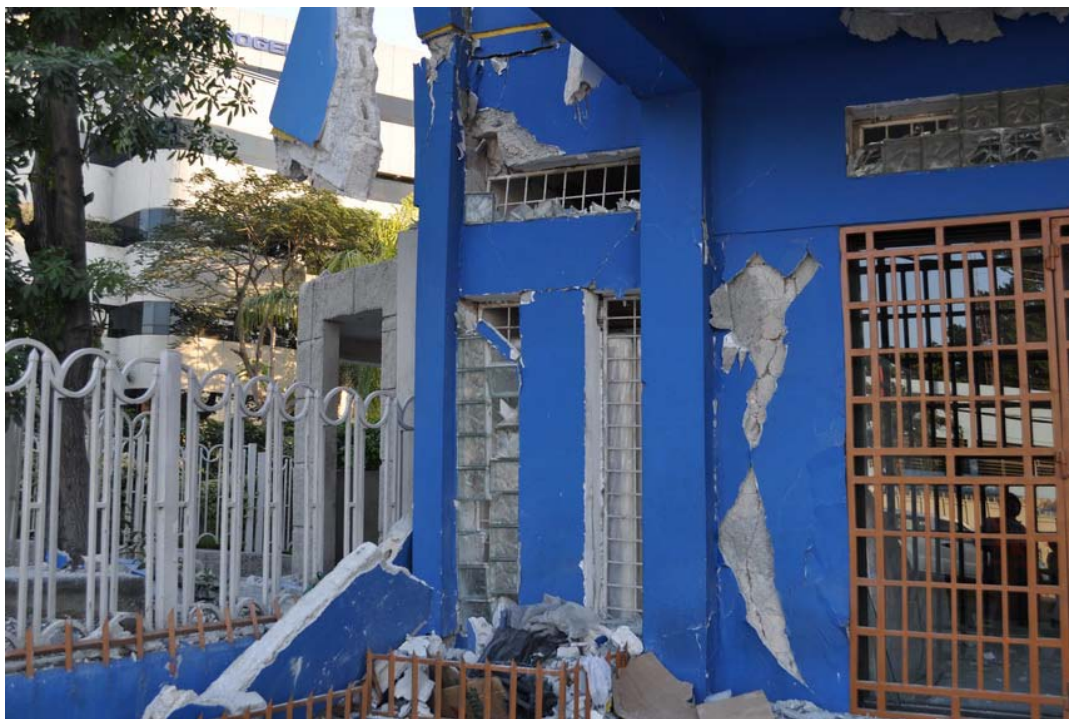
Figure 6.3.1.5-1 Damage to glass block in building with reinforced concrete frame and concrete masonry infill in the magnitude-7 2010 Haiti Earthquake (Photo courtesy of Eduardo Fierro, BFP Engineers). Note some blocks failed at rigid mortar joints and stayed in the frame, others fell out of the frame, and others broke in place. This building also suffered structural damage.
